Automotive Phosphate Stage 2 and 4 Tank & Housing Refurbishment

Project: Automotive Phosphate Stage 2 and 4 Tank & Housing Refurbishment Project

On June 26, 2010 the contractor Ultimate Corrosion Control Inc. commenced the job at 7PM and completed the job July 3, 2010 at 7AM. The scope of their work was to abrasive blast and line two tanks and the housings over those tanks. This report describes the Stage 2 Alkaline Cleaner tank, the more technical and critical portion of the job.

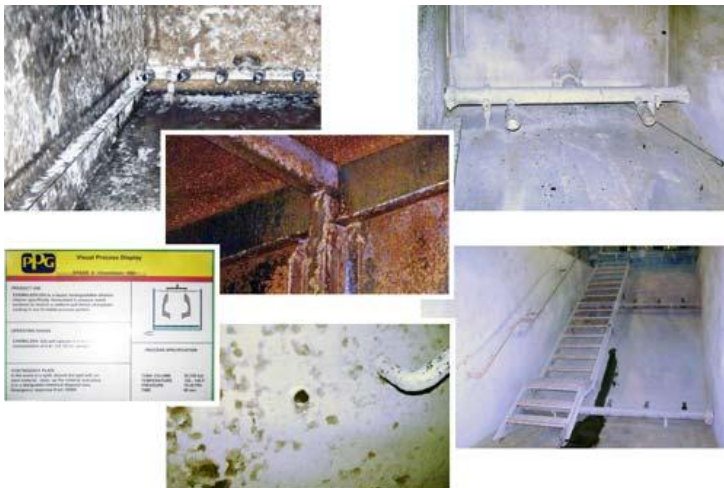
The Stage 2 and 4 Tanks & Housings were in severely deteriorated condition at the time this Refurbishment Project was funded. The upper housing had many perforations before the sandblasting operation for metal preparation. Many holes had to be covered and filled with fiberglass to restore the integrity of the enclosure.

The Stage 2 steel alkaline cleaner dip tank at a Midwest automotive plant had problems with early corrosion issues in the tank and housing. The operating conditions in this

tank were alkaline cleaned at 130° F immersion temperatures. RO water was used in make up water adding to the corrosion issue. The tank is also boiled out (chemically cleaned) from time to time with strong alkaline solution at 150° F to remove oil and grease and sludge.

The experts at Chemical Containment and Advanced Polymer Coatings were consulted to come up with a polymer lining solution for this challenging application. A plan was initiated with very innovative ideas to provide a long term lining solution to protect and prolong the life of the Stage 2 and 4 Tanks & Housings for a decade or more.

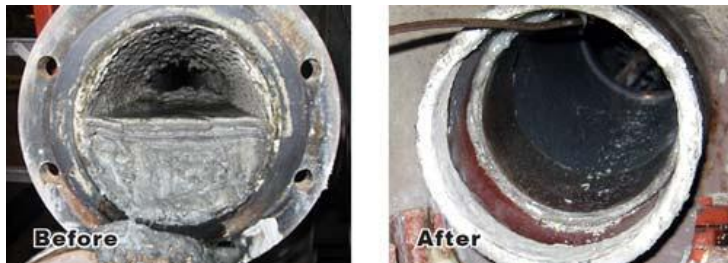
Existing Stage 2 Eductor Headers were extremely fouled with oily sludge resulting in very poor flow and distribution of pumped process solution.

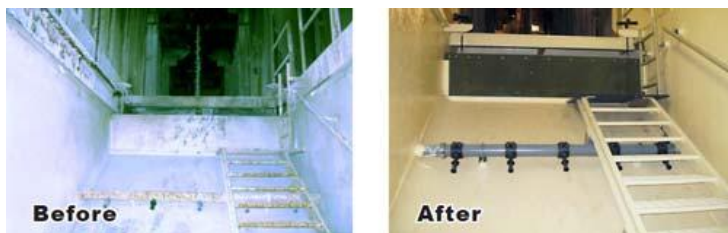
Stage 4 Steel stairs, handrails, and internal piping were extremely corroded.

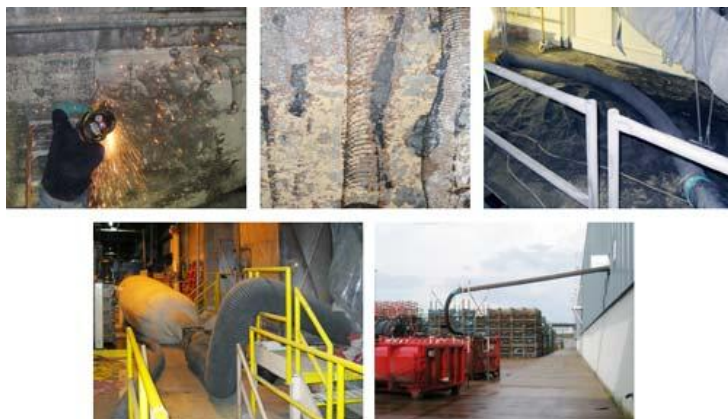
Top row, left to right: Removal of existing fittings; water-jet swirls on tank walls shows the many layers and coatings being removed; protective cover

over tank during blasting/coating.

Lower photos, left to right: air bag for collecting blasting debris; debris collection and removal system.

All surfaces to be lined surface prior to abrasive blasting were cleaned by with a hydro-jet at 30,000 psi. All surfaces were free from contamination from grease, oils or salts.

After cleaning, the surface was abrasively blasted to SSPC-SP5 (NACE #1, SA3) white metal finish with 3 mil profile. Black Beauty 1240 was used in accordance to specification of the coating manufacturer, Advanced Polymer Coatings. The blasting debris was collected in vacuum boxes and the airborne contaminants collected in large dust bags.

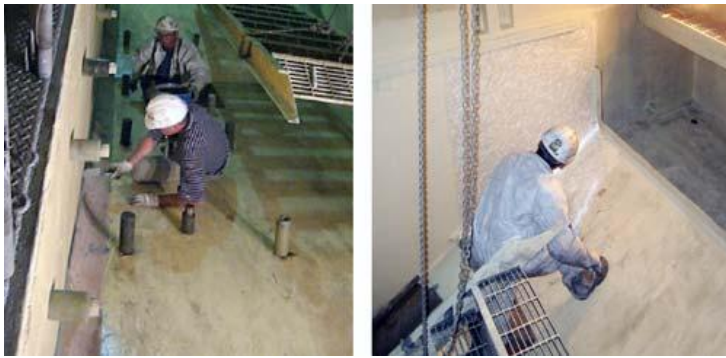
Added between the primer coating and the final coating, fiberglass reinforcement improves the lining's resistance to damage.

Once the prime coat was completed in both tanks, UCC applied fiberglass reinforcement prior to the full coat application. With fiberglass reinforcement the lining will be resistant to scrapes, and gouges from parts falling, dragging and piling up in the tank bottom and sides

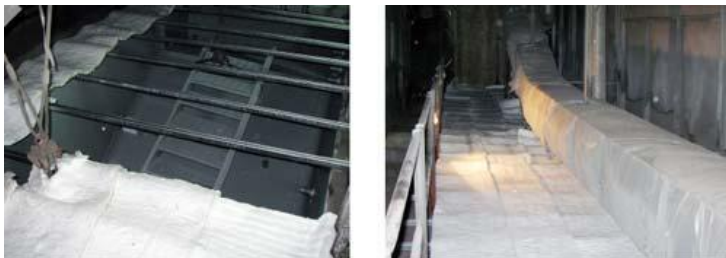
Above, Ceramic insullation was used to control humidity and temperature within the tank.

Left, A top coat was applied using ChemLINE 784/32.

A second full coat of ChemLINE 784/32 (Gray) at a wet film thickness of 7-8 mils was applied to achieve 6-7 DFT top coat.

The tank was covered with 2" of ceramic insulation and held in place using Unistrut placed perpendicular to travel.

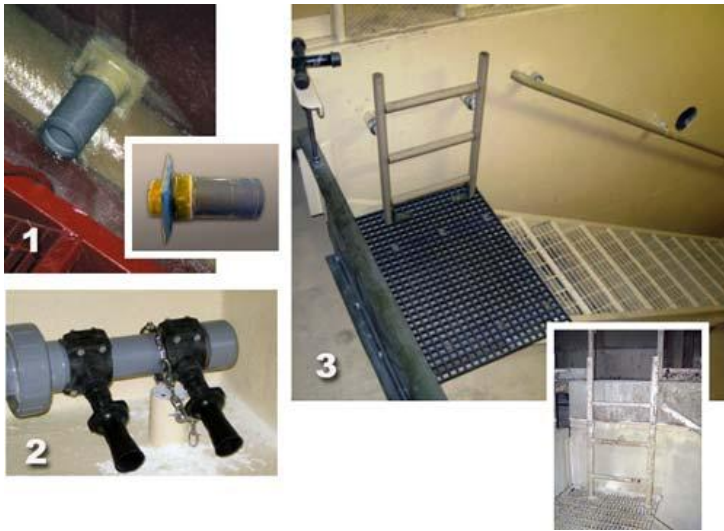
1. Fiberglass Inserts - The fiberglass inserts shown in the fabricating process and installed.

2. Pipe Supports - Shown with adjustable chain.

3. Fiberglass Handrail, Ladder and Grating - Traditional equipment was replaced with fabricated fiberglass. Shown right, the area before replacement.
